AEFA Project No. 88-06-1

NATURAL ICING RE-EVALUATION OF THE EH-60A QUICK FIX HELICOPTER

May 1989

Final Report

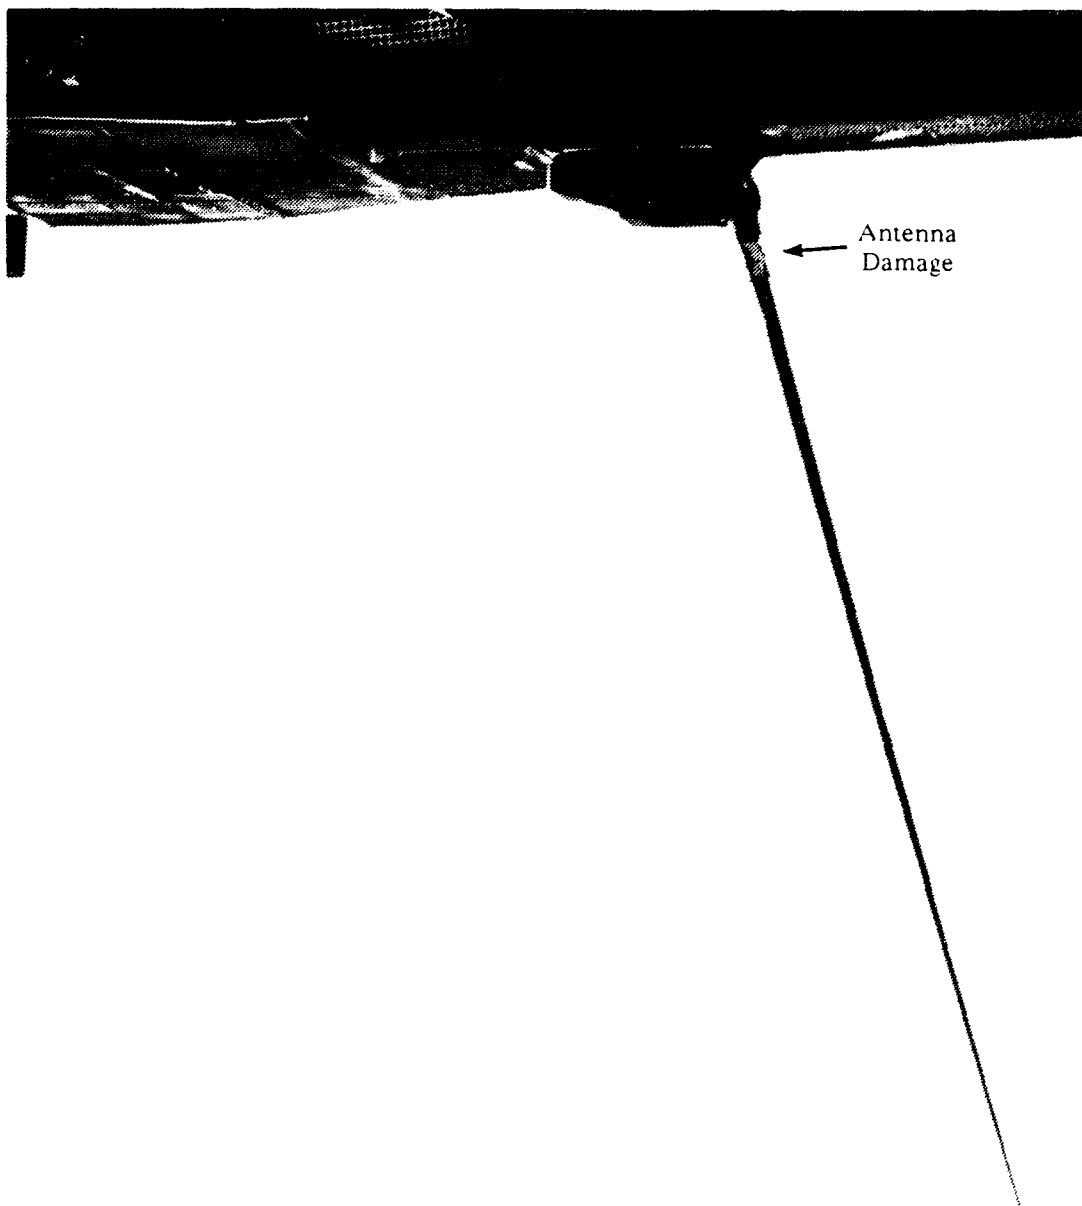
Figure F-2. ECM Antenna Extended Post-Failure (Flight #3)

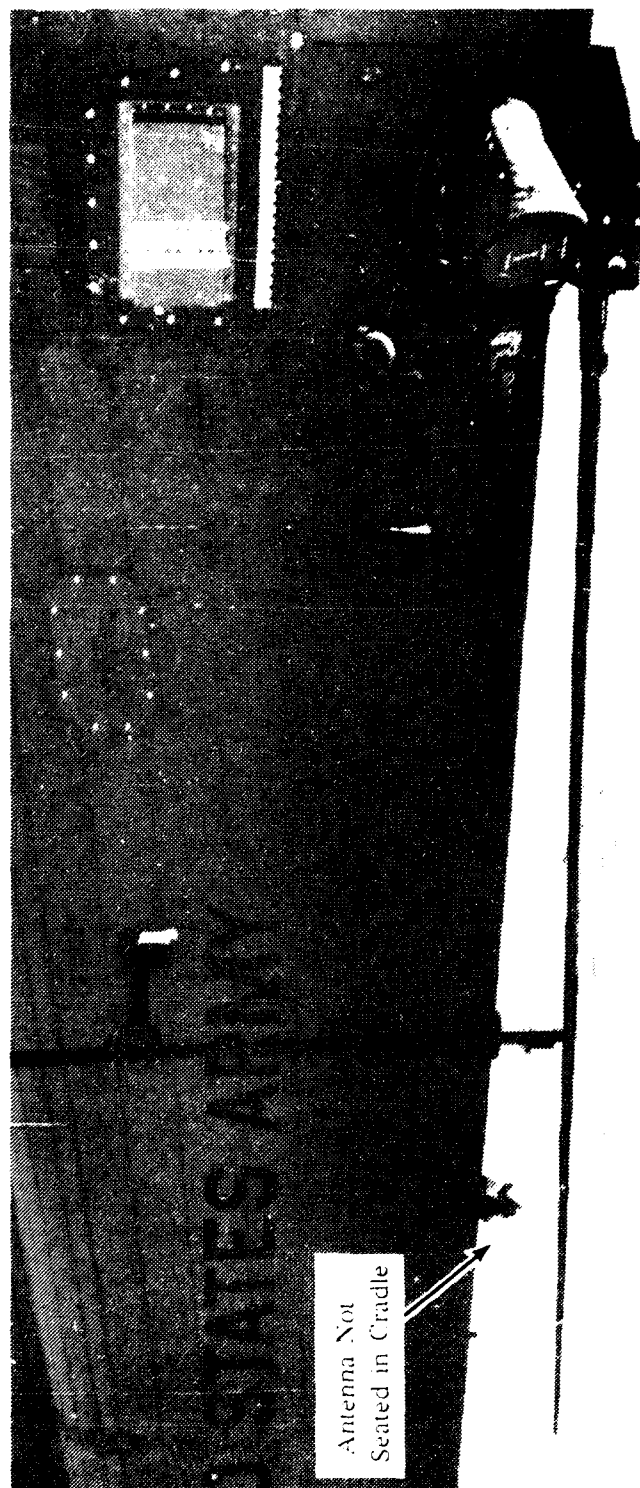
Figure F-3. ECM Antenna Retracted Post-Failure

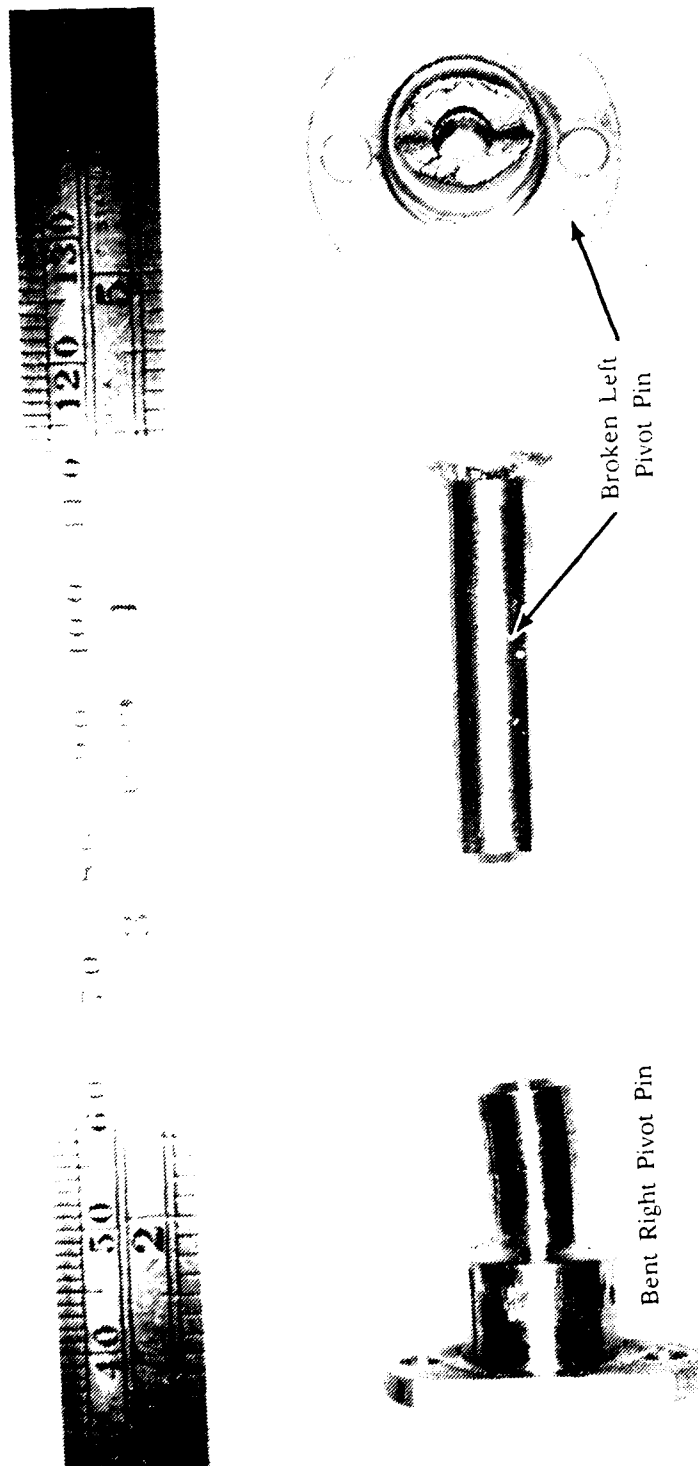
11. Post-flight airframe inspection revealed the following damage: a fatigue fracture of the left pivot pin which allowed the antenna to move laterally and bend the right pivot pin (fig. F-4); cracks in both the composite actuator mounting structure and the metal ground plane (figs. F-5 and F-6); and debonding and loss of material at the joint between the base of the antenna and the insulation collar (fig. F-7). After a review of the in-flight video recordings, the foregoing damage was attributed to the lateral oscillations of the ECM antenna. During antenna retraction the misalignment caused by the pivot pin

Full Description of Incident:	
<p>At the completion of a natural icing test flight of 1.4 hr. duration, -14.0° C and with an average LWC of 0.27 g/m³, a post flight inspection revealed a broken right pivot stud on the ECM antenna actuator assembly. In the area of the sheared stud, damage was also apparent on the actuator mounting/housing and the moveable antenna mounting plate.</p> <p>Additional damage was noticed during the post flight inspection: the ECM antenna (TIR #EC-B88061002), the ground plane/honeycomb skin sandwich structure (TIR #EC-B88061004), and the left pivot stud (TIR #EC-B88061005).</p>	
Name, Title & Phone of Preparer: 98. JOSEPH L. PIOTROWSKI Project Engineer, AV 527-4992	FOR THE COMMANDER: 99. PAUL W. LOSIER, MAJ, AV Chief, Plans & Programs

30. Title: Bent Pivot Stud	40. Date & Time: 7 March 1989, 1600
31. Subsystem:	41. FD/SC Step#:
32. Incident Class: MAJOR	42. FD/SC Class:
33. Category: R&D	43. Chargeability: Hardware
34. Observed During: Post flight inspection	44. Preliminary CA Status: Open
35. Action Taken: Removed	45. Asgd Resp:
36. Test Environment: Natural Icing	
37. Defective Material: Returned to TRACOR Aerospace

Broken Left
Pivot Pin

Bent Right Pivot Pin

Figure F-4. Damaged ECM Antenna Pivot Pins

29. The deficiency noted at paragraph 23a should be corrected prior to further icing flight tests of the EH-60A with the ECM antenna extended (paras 10 and 11).

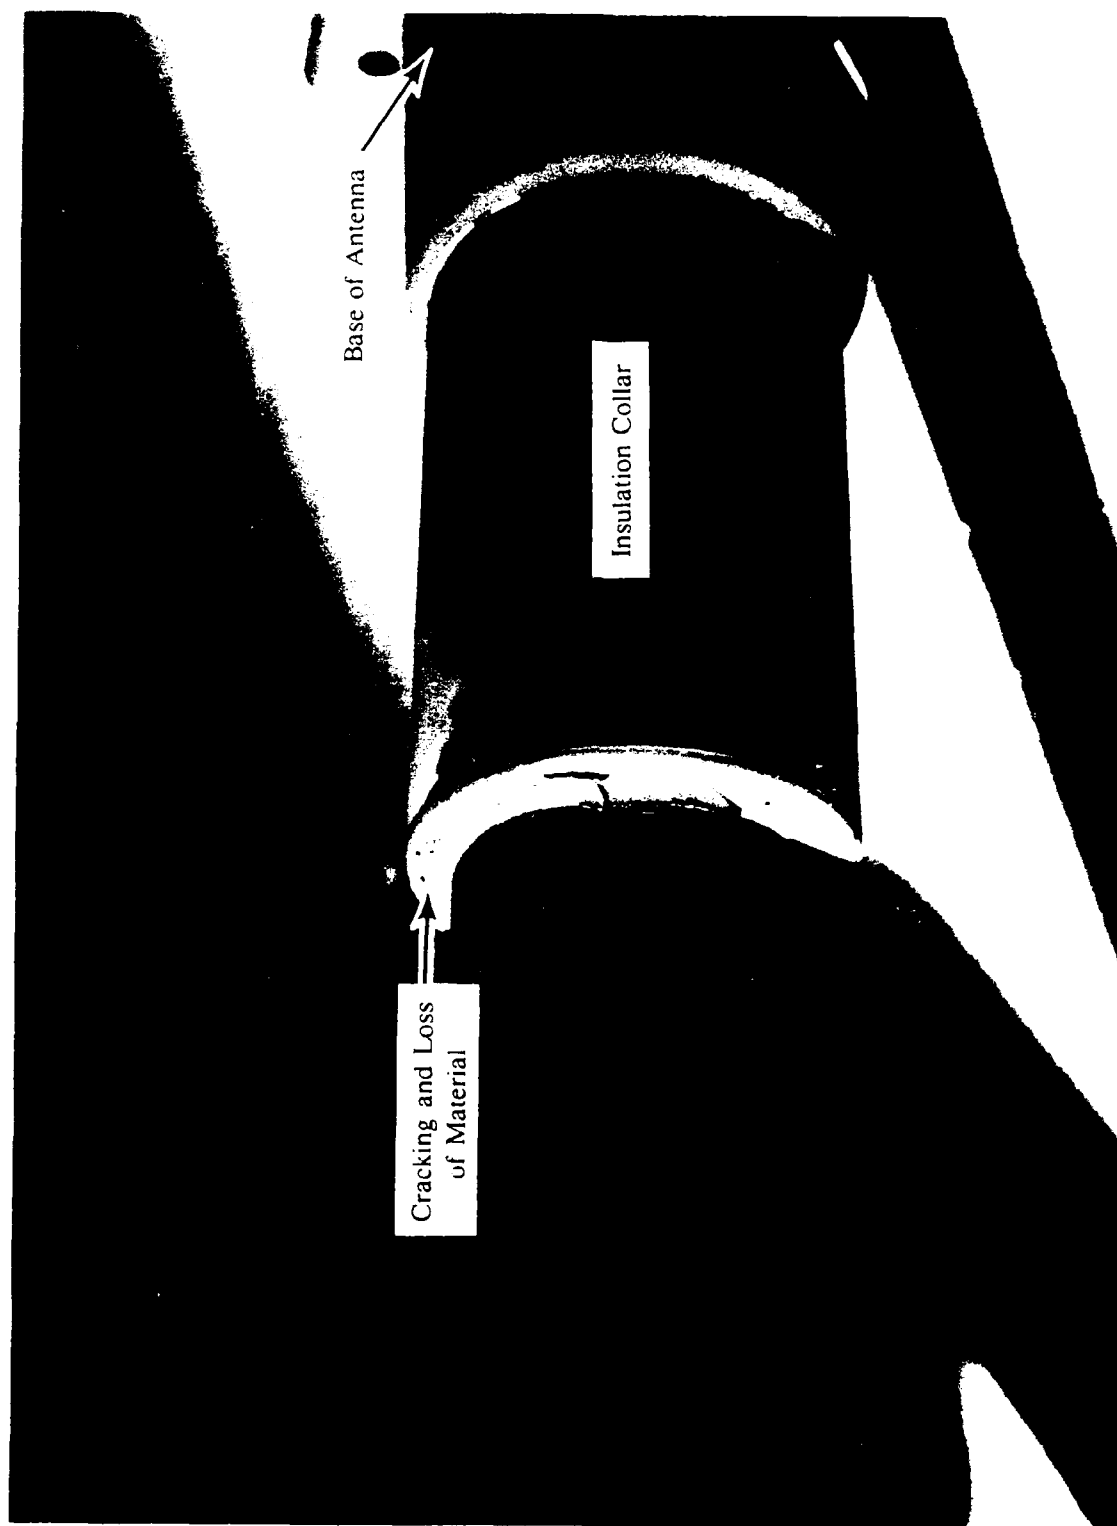
1. Description of Incident:	
<p>After a natural icing test flight of 1.4 hr. duration at -14.0° C with an average LWC of 0.27 g/m³, the ECM antenna failed to fully retract. During the test flight the ECM antenna had oscillated laterally. After approximately 33 minutes, the antenna stopped oscillating and hung slightly to the right of the normal extended position.</p> <p>Post Flight inspection revealed a debonding between the aluminum ECM antenna and the fiberglass insulation bushing at it's base. Various patches of paint were missing from a spot about 3 feet from the antenna tip. (Continued on attached sheet)</p>	
2. Name, Title & Phone of Preparer:	FOR THE COMMANDER:
JOSEPH L. PIOTROWSKI	99. PAUL W. LOSIER, MAJ, AV
Project Engineer, AV 527-4992	Chief, Plans & Programs

Figure P-7. Damaged ECM Antenna Base

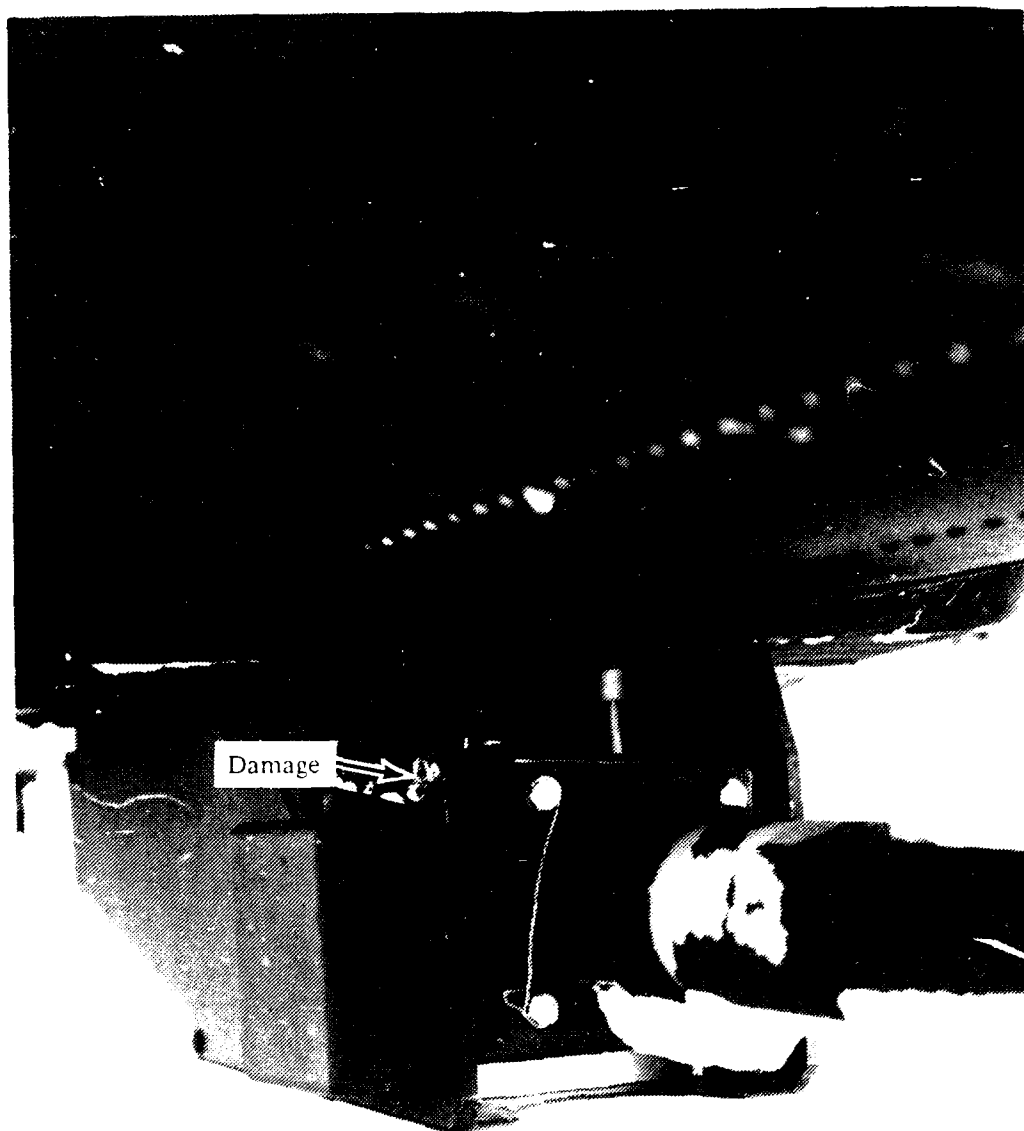
failure had allowed the antenna base to contact the actuator mechanism causing damage to several components (figs. F-8 and F-9). The damaged ECM antenna assembly and mount were replaced by a blanking plate during subsequent flights. The design of the antenna assembly and mount is deficient because it allows excessive ice-induced oscillations, resulting in structural damage and component failure. The design of the ECM antenna/mount assembly should be improved to either prevent ice accretion or render the ice-induced oscillations benign. Further testing should be conducted before the EH-60A is released for flight in icing conditions with the ECM antenna extended. Testing should be accomplished to determine the effect of ECM antenna ice accumulation on the operation of the AN/ALQ-151(V)2 countermeasures system.

Figure F-8. Damage - ECM Antenna Actuator

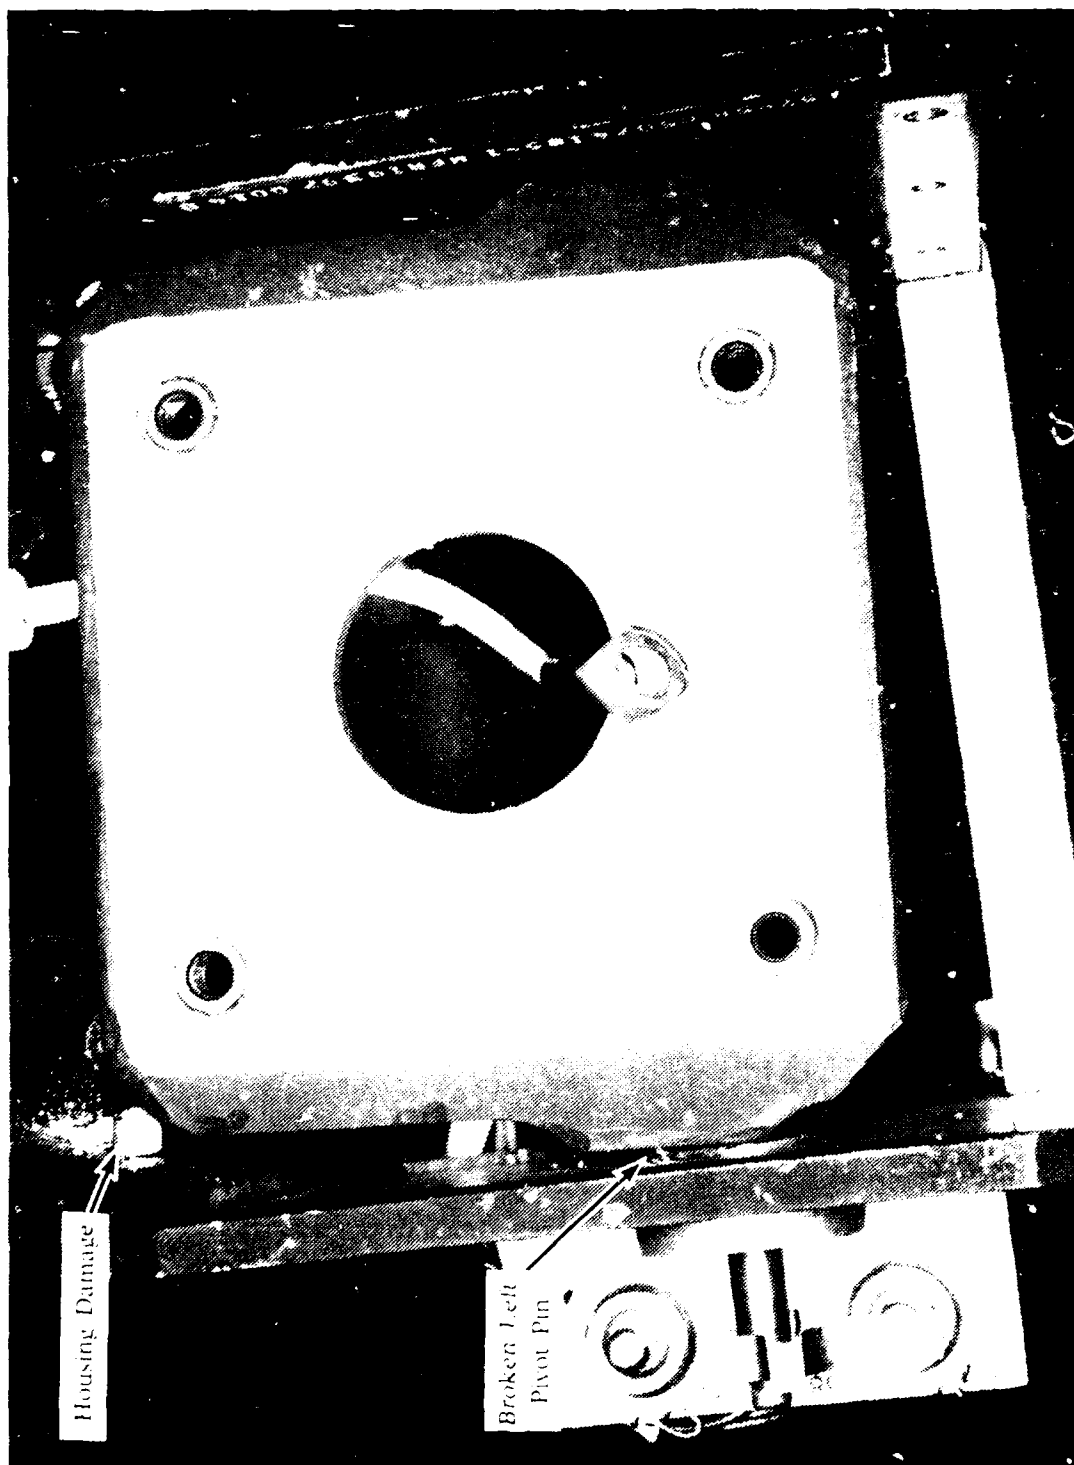
Figure 1-9. Damaged ECM Antenna Actuator
